WEEKLY OVERSIGHT REPORT

CH2MHILL**Weekly Summary Report
USEPA Oversight, Sauget Area 2, Sauget, IL
WA No. 224-RXBF-05XX / Contract No. 68-W6-0025****Week Ending Friday, September 24, 2004**

This report summarizes the Interim Remedial Action (IRA) work conducted by Solutia and its contractors from September 17 through September 24, 2004 at Site R, Sauget Area 2. The current IRA fieldwork consists of site preparation, barrier wall trenching, and backfilling, with excavation performed on day and night shifts.

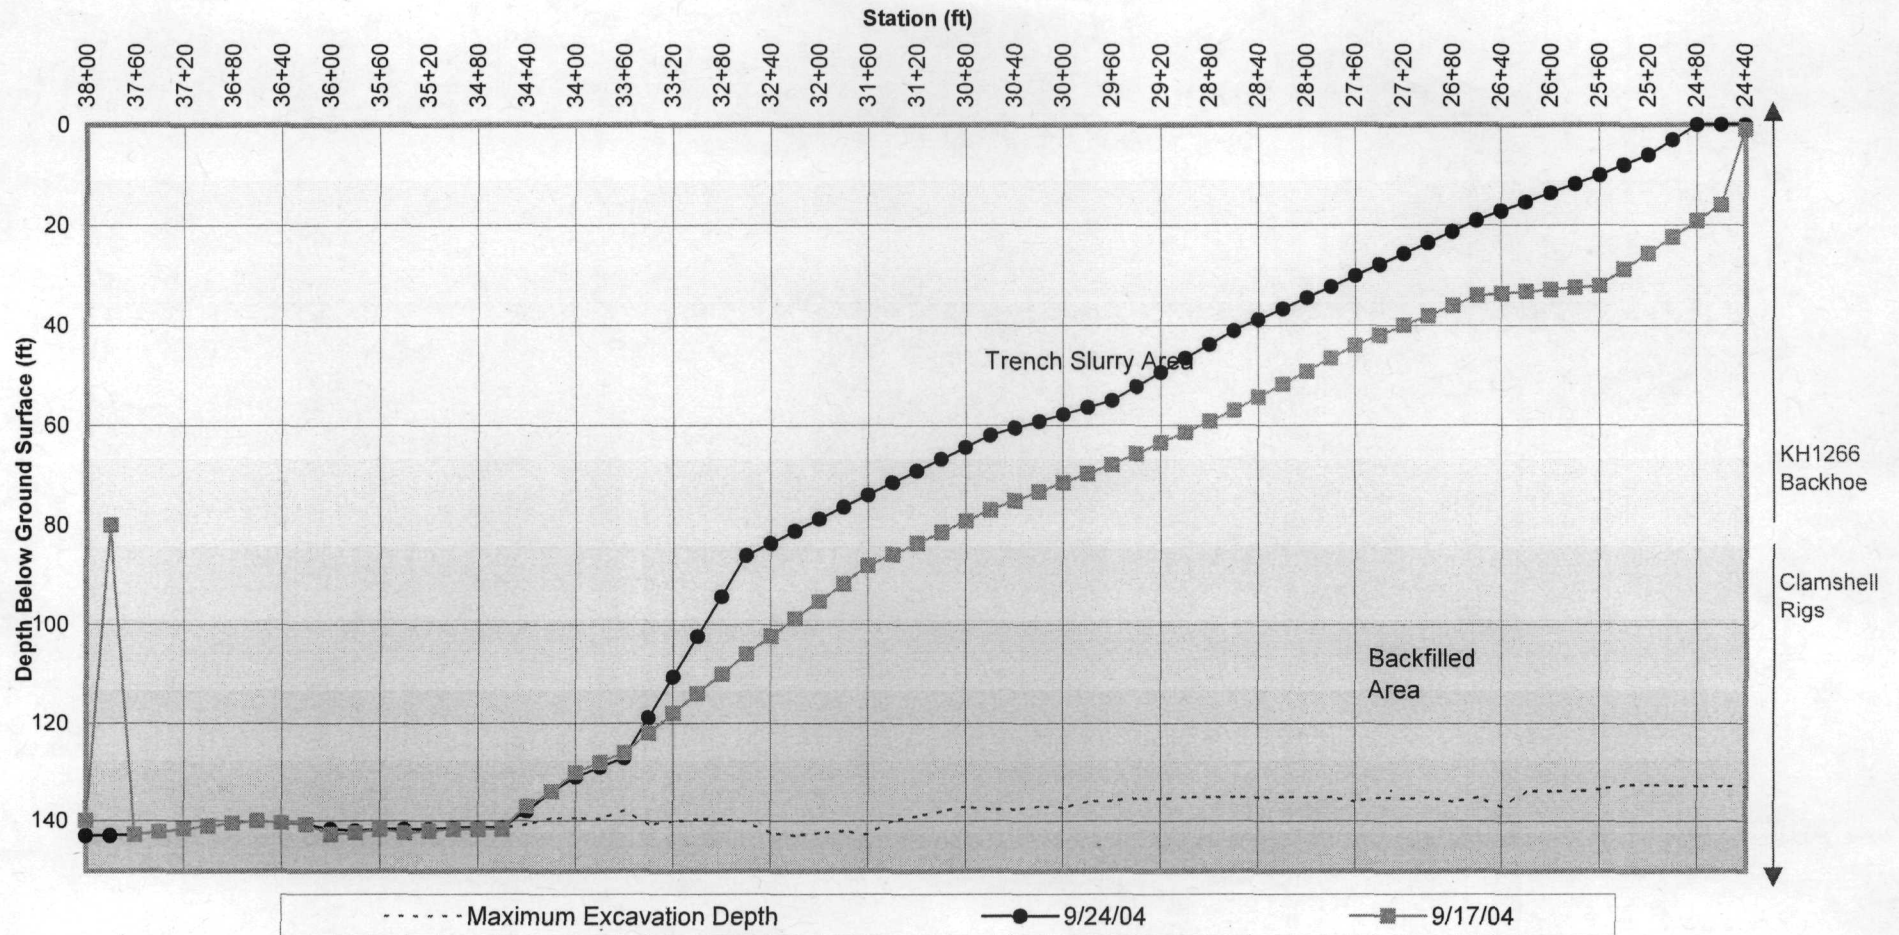
Graph 1 - Weekly Barrier Wall Construction Progress - Open Trench Segment
September 17 through September 24, 2004

During the week, the depth of the open trench was measured daily. Table 2 summarizes the trench profile that was measured on the morning of September 24. On Graph 1, the current trench profile is depicted in comparison with the trench profile measured on September 17. Graph 2 shows the overall progress of the barrier wall construction.

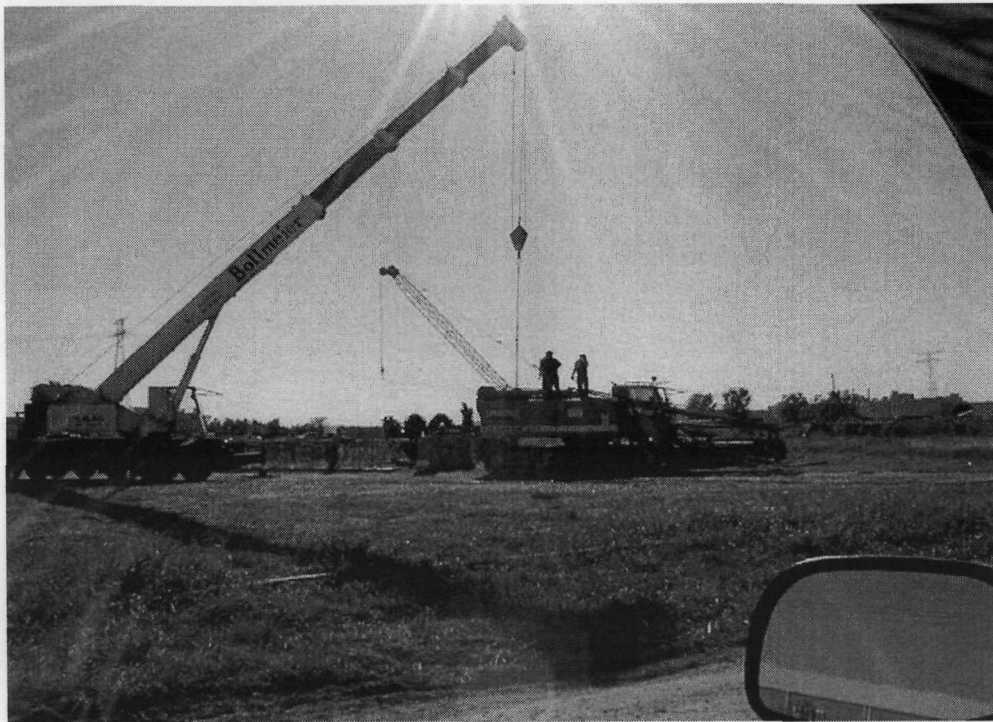
Demobilizing the Liebherr 843 hydraulic clamshell. (September 23, 2004)

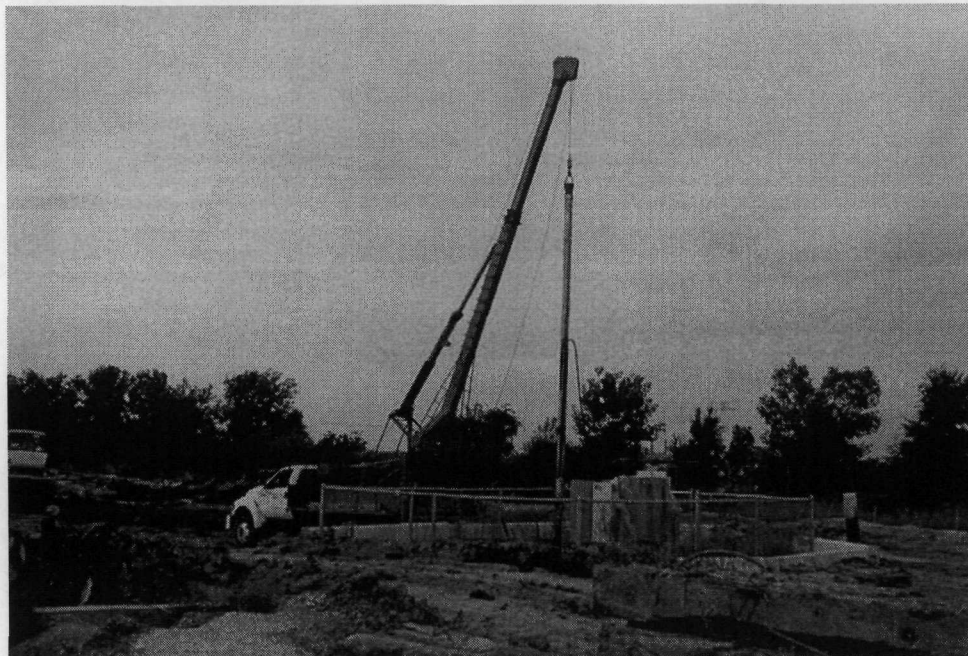
855 Mechanical Clamshell being removed from exclusion zone (September 24, 2004)
